# Archaeological Investigations at the ca. 1783 Log Stable, Loatman Road, Lower Hopewell Township, Cumberland County, New Jersey

Formerly known as the “Swedish Granary”

Lu Ann De Cunzo, Ph.D.

July 2024

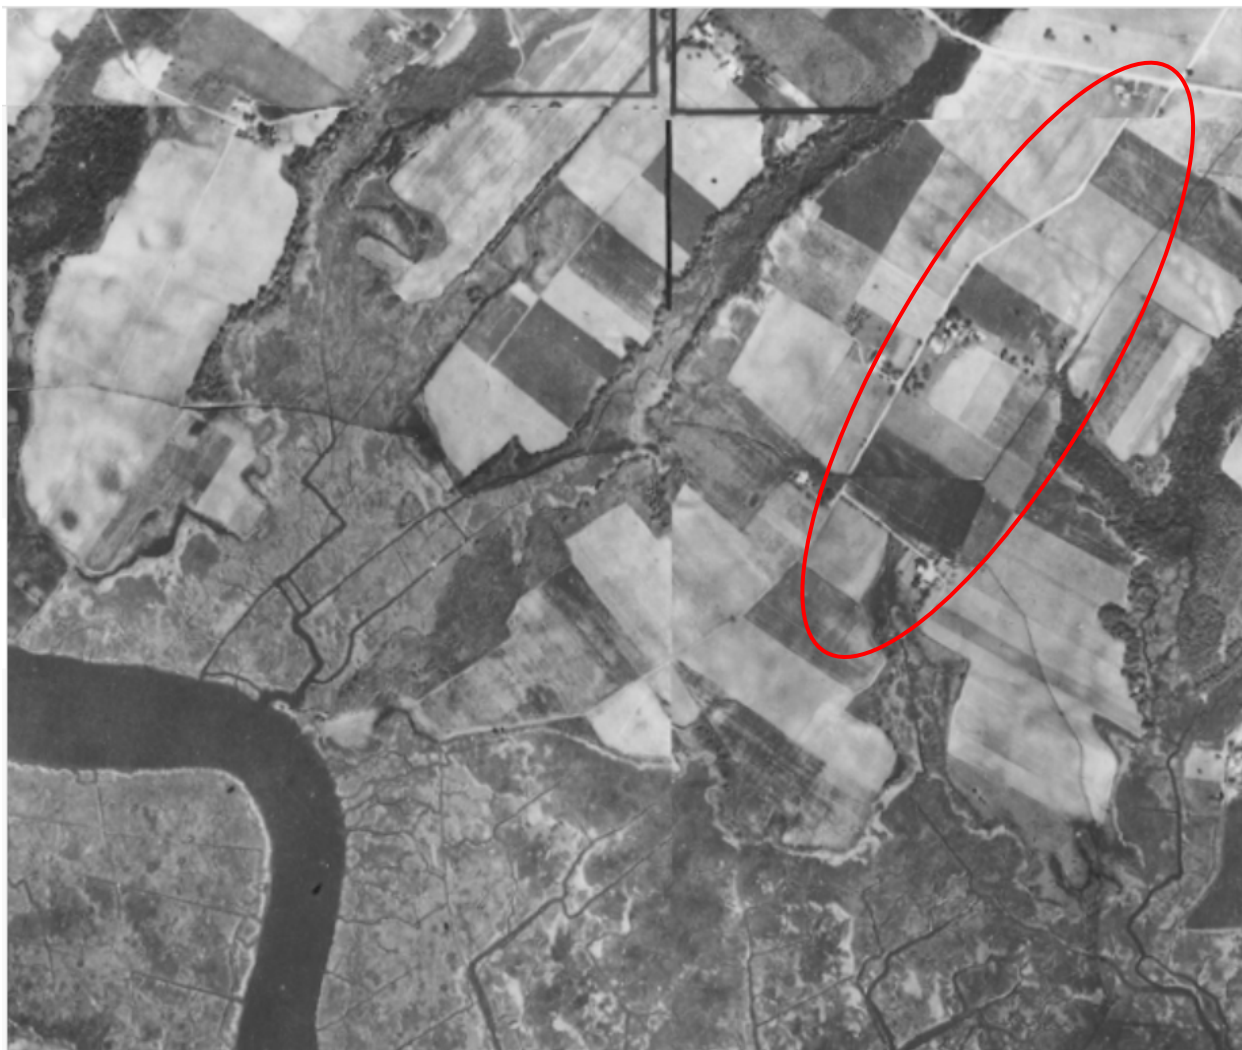
Figure 4: Close-up of Loatman Road and then Perry Farm (outlined in red), 1930 Aerial Map, Cumberland County, NJ.

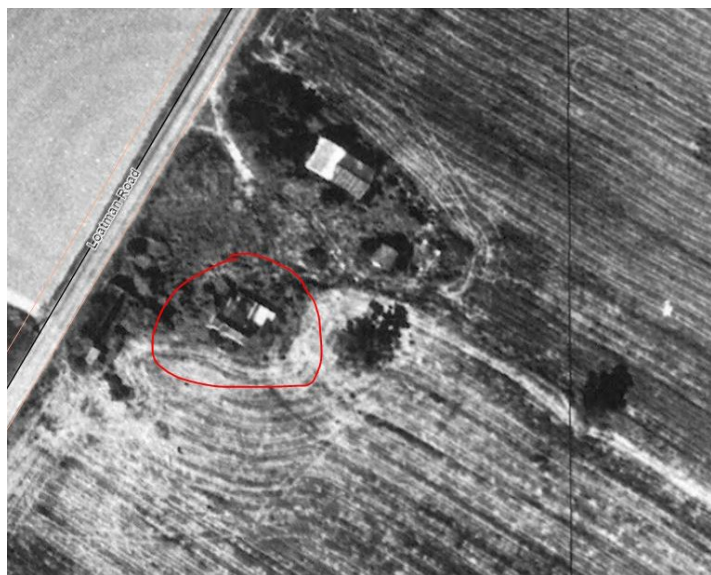
Figure 5: 1970 aerial photograph showing the farmstead with the house and three outbuildings. The log stable is circled in red. [NJ Geo-Web, 1970 Wetlands Black and White Imagery overlay]. Reproduced from Berkey 2023, Figure 7.

Robert Fralinger Jr., a local peach and poultry farmer, purchased the farm soon after Perry's death in 1969. A 1970 black and white aerial photograph clearly shows a farmhouse with "three outbuildings to the south. The largest of the outbuildings is the southernmost one [circled in red in Figure 5] which is the log stable with its two shed additions. In 1974, after Robert Fralinger decided to donate the log stable to the Cumberland County Historical Society, restoration architect G. Edwin Brumbaugh of Gwynedd Valley, Pennsylvania visited the farmstead to examine the stable at its original location."

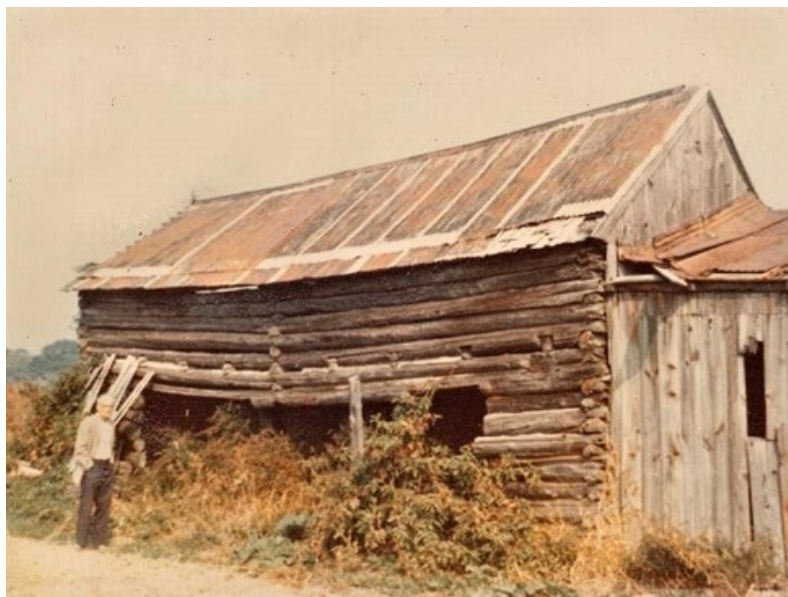
A ca. 1961 image shows that the building was no longer in use, and the area around the building was plowed almost to the building foundation (Figure 6). A second image shows the rear open shed supported by posts, likely used for farm equipment storage (Figure 7). The building surroundings are not as overgrown as they appear in later images, but the vegetation does obscure the foundations. Later, but pre-1973 images show the building abandoned, in disrepair, and surrounded by overgrowth. Sheds are attached to the south (rear) and east walls of the building.

Figure 6: The log stable. Original photographer unknown. Photo dates uncertain, but if 1961, man could be Elmer Gandy. Reproduced from Reed 2023, Image 13.

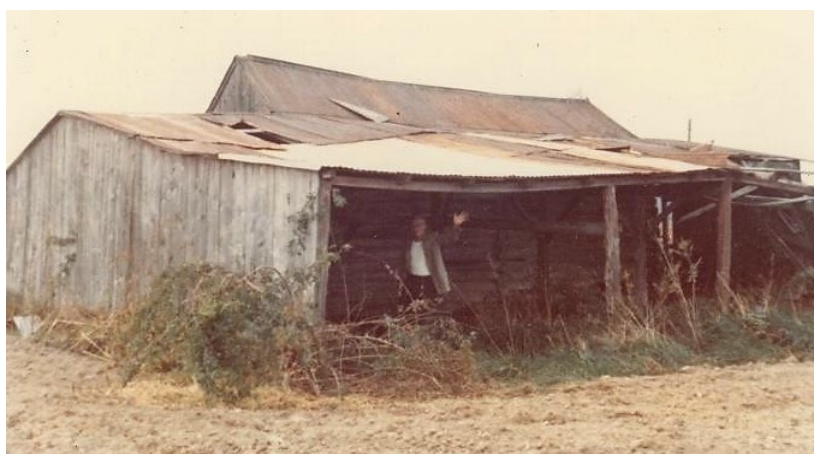
Figure 7: The log stable with rear open shed addition supported by posts. Unknown photographer and date. Same man as in Figure 6. Image courtesy of CCHS. Reproduced from Reed 2023, Image 14.

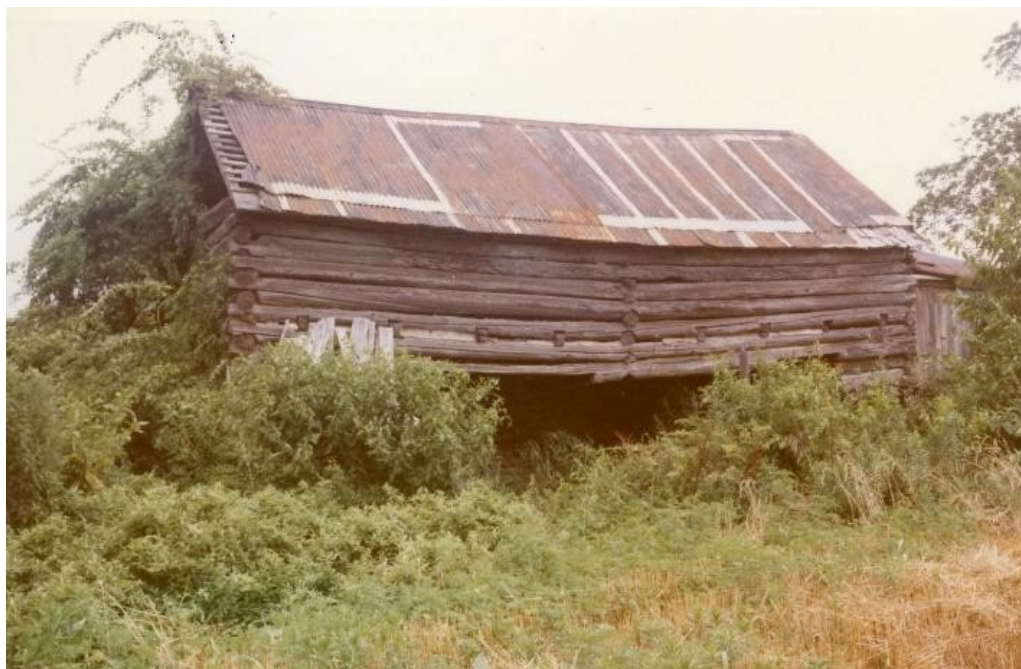
Historical architect G. Edwin Brumbaugh consulted on the building history and significance. July 1973 photos taken during his site visit show heavier overgrowth, making it impossible to see the presence and condition of any foundations. One Brumbaugh image and a slightly later image taken inside the shed show the log building sill resting on rectangular stone, concrete, or stone set in concrete corner piers set with the long edges paralleling the building front and rear walls (Figures 8). It is not clear if the supports rest on the soil surface or extend below ground. An uneven layer of cobbles and fractured stones, with many gaps, were tucked under the building sill between the corner posts. This may be a meager attempt to discourage vermin from getting under the floor.

Figure 8: Photograph by G. Edwin Brumbaugh, 26 July 1973. Brumbaugh archives, Col 34, Box 8, Greenwich, Winterthur Library. Reproduced from Reed 2023: Image 12.

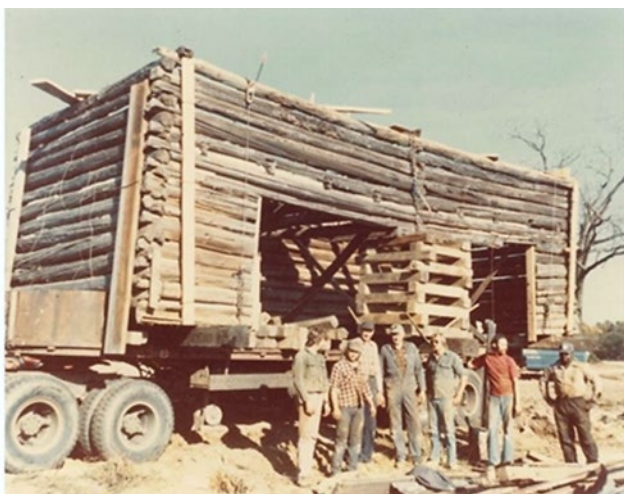
A subsequent image taken after the log building was transferred to the flatbed shows some of the logs and frame members left behind. They appear in a shallow depression, suggesting more soil removal while preparing for lifting the building than just trenching to install carrier beams (Figure 11).

Figure 11: Photographer unknown, Fall 1974. From Architect Penelope Watson. Courtesy of CCHS. Reproduced from Reed 2023: Image 19.

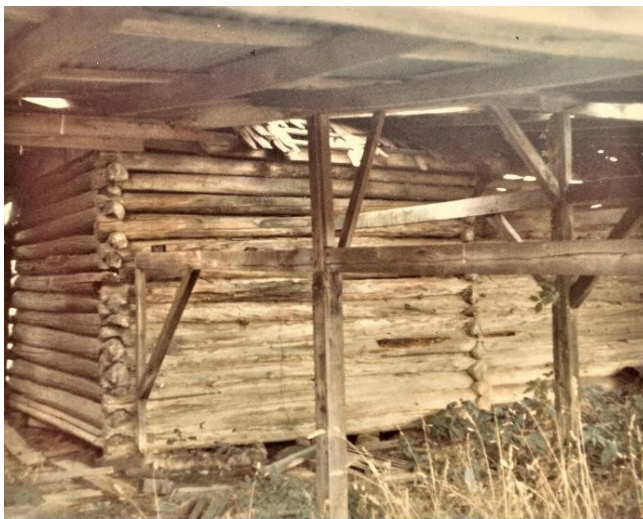
Preparations to lift the log stable for removal to Greenwich in 1974 compromised the archaeological integrity of the Holmes farm site. Removal of sheds, clearance of vegetation around the stable, trenching and scraping to insert the carrier beams and provide access to lift the stable onto the flatbed truck for transport, and site clean-up following the move all contributed to the loss of archaeological evidence. Surface-laid foundations and shallow corner piers, the stable and shed flooring, and layers of soil that accumulated around the building during its tenure on the site were removed, displaced, and relocated, or smeared around the area. [Note that surface-laid board flooring appears in one of the stable additions; Figure 12]. No pre-1975 photographs of the interior of the main log stable have been located to indicate whether it had board or dirt flooring.

Figure 12: Photographer unknown, before Fall 1974. Reproduced from Reed 2023, Image 16.

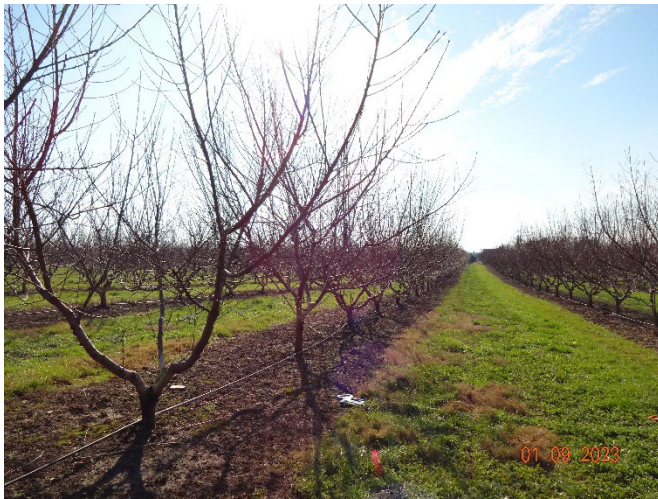
Figure 15: Rows of peach trees in project area, Fralinger Farm, December 2023. Photograph by the author. Looking southwest.

The site hosts 4-year-old peach trees, the third generation planted in the field. The trees stand ca. 13' apart in the middle of a ca. 11'-wide row of exposed. The ca. 15' corridors between trees are planted with grass, mowed regularly for access to the trees. 'Subsoiling' precludes the need for an underground irrigation system. The trees are sprayed in the fall, and when in bud in the spring; they are harvested about the second week of June. Small brick fragments appear occasionally on the exposed soil surfaces around the trees in the project area (Figures 15-17).

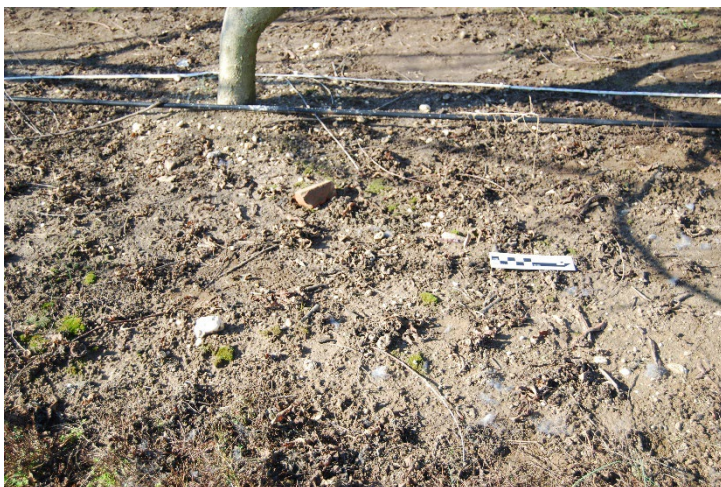
Figure 16: Close-up of exposed soil corridor in which trees planted, showing brick fragments. Project area, Fralinger Farm, December 2023. Photograph by the author. Looking west.

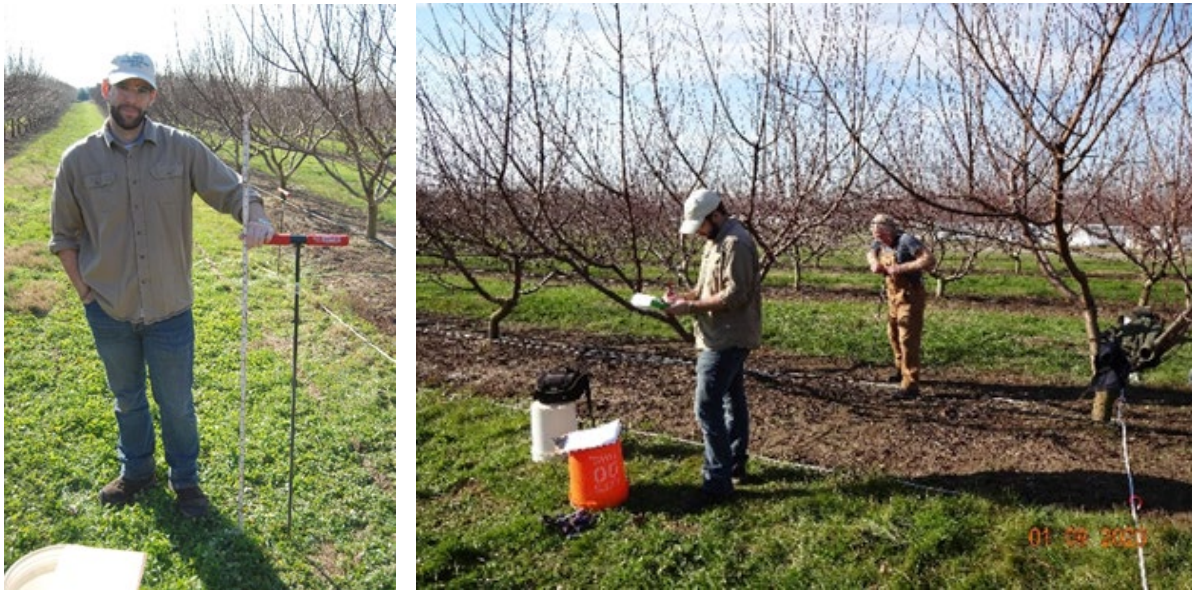
To lay out the grid, we extended the south longitude ca. 0.8' to establish the southeast corner of the grid. Using triangulation, we laid out a 30'-square grid extending north and west of that point. Working in two teams, De Cunzo and Mathews (Columns 6-10; Mathews probing), and Adamczyk and Jones (Columns 1-5; Adamczyk and Jones alternately probing), we placed 110 probes at 3' intervals, including the 30' x 30' border of the study area. Pressure was exerted on the probe until no further penetration into the soil was possible. The length of the 4' probe remaining exposed was measured and recorded; this was later converted to depths below surface (Figures 18-19).

Figures 18 and 19: Field probe survey, showing grid boundaries, probe and probe in use, recording. Richard Adamczyk, both figures; Clifford Jones probing, Figure 19. December 2023. Photograph by author.
